**Restoration of Osborne Tire Reef
Status Report
Fiscal Year 2023-24**

**Office of Resilience and Coastal Protection
Florida Department of Environmental Protection
December 2023**

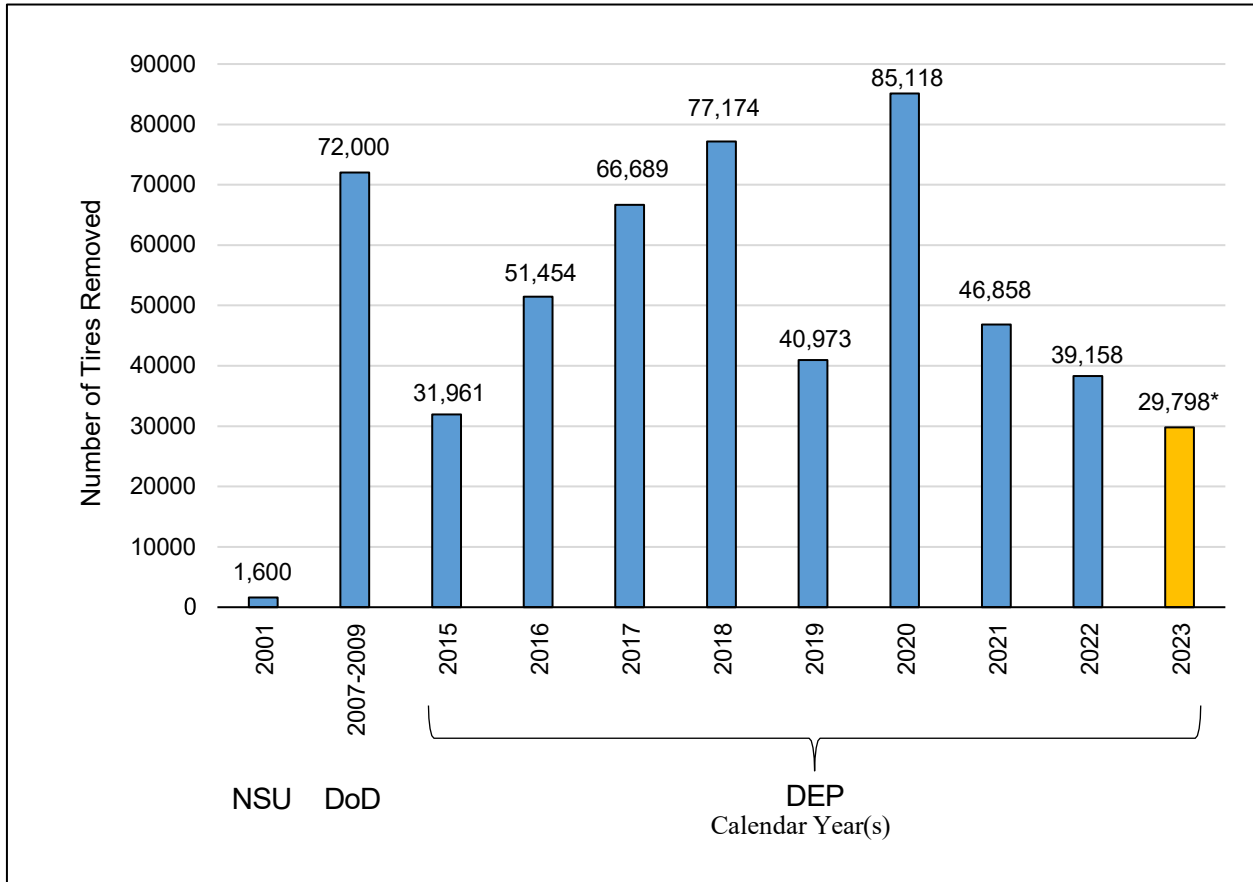
Figure ES-1. Number of tires removed per calendar year for each tire removal program from 2001 to the present. This graph does not include tire removal efforts from 4Ocean (414 tires). *Number of tires removed as of the most recent tire removal report in September 2023. NSU = Nova Southeastern University; DoD = Department of Defense; DEP = Florida Department of Environmental Protection.

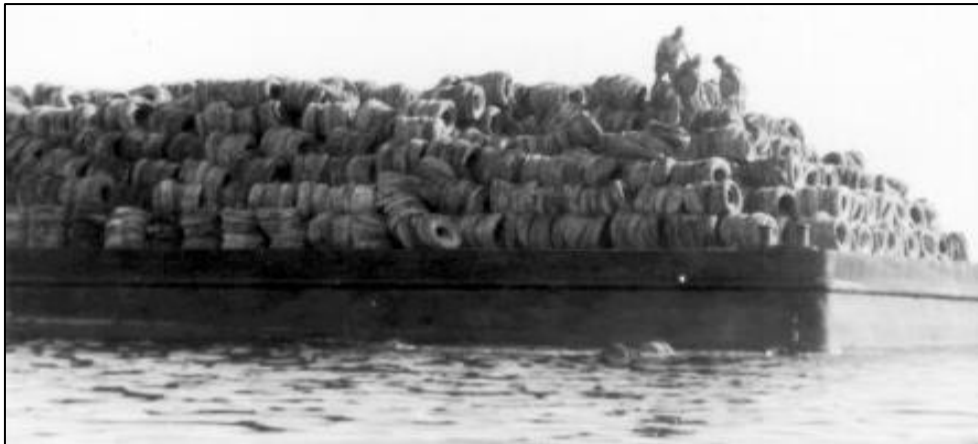
Image 1. Most of the tires deployed in the 1970s were placed as bundles.

While records are unavailable for many of the tire deployment events, there are reports of tires being placed in groups as large as 50,000 (April 1972) and 190,000 (November 1973) (D.E. Britt Associates, 1974). Actual deployment methods ranged from bundled tires being transported on a barge (Image 1) and dropped using a clamshell crane to single tires being deployed by citizens from private vessels (Image 2). Poor record-keeping, lack of monitoring and issues associated with deployment are the primary reasons why a more precise estimate of the total number of deployed tires is unavailable.

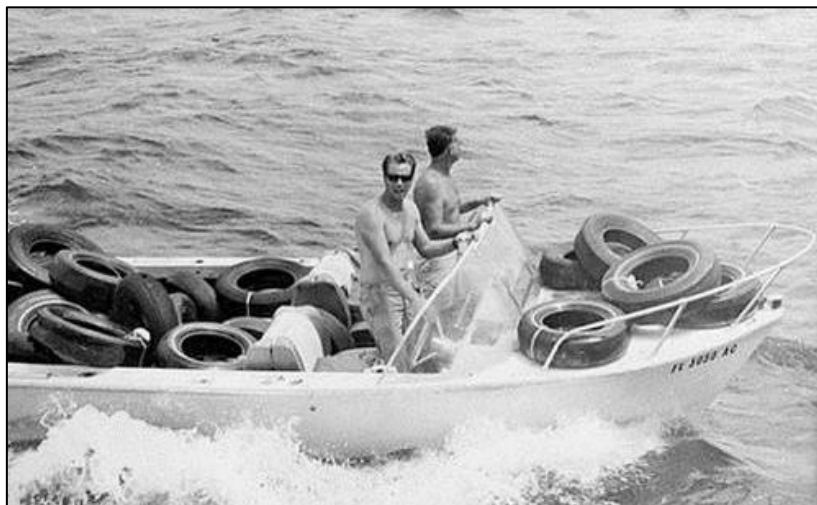
Image 2. Tires were also deployed individually from private vessels.

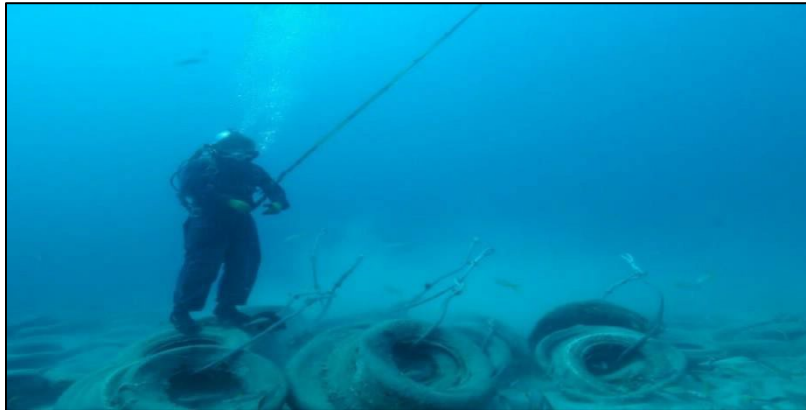
Image 9. Surface air supplied diver hand bundling tires for transport to the surface by crane (Photo: Industrial Divers Corporation [IDC]).

In 2015, DEP began tire removal operations in the Tire Abatement Permit Area using a contractor. To expedite the removal process, priority was given to those tires without biological growth (i.e., corals and sponges). The removal method typically requires a single diver on the bottom bundling tires (Image 9). The bundle is hoisted onto the surface support vessel using a surface crane or winch (Image 10). Once the vessel is fully loaded (approximately 300 tires), the vessel travels to Port Everglades and unloads the tires into an open-top trailer staged on the port property. From Port Everglades, the tires are transported to a waste tire processing facility for proper disposal. This was determined to be the least environmentally destructive method available considering proximity of tires to natural and artificial reef and permit-required buffer zones around those habitats (as described in **Habitat Overview**). In some subsections of the seafloor, tires have been completely cleared over the course of several years (Images 11 and 12). The number of tires removed during this project as of September 2023 is 469,183. Further details on tire abundance and timelines for tire removal are discussed later in this document (see **Estimated Tire Abundance**).

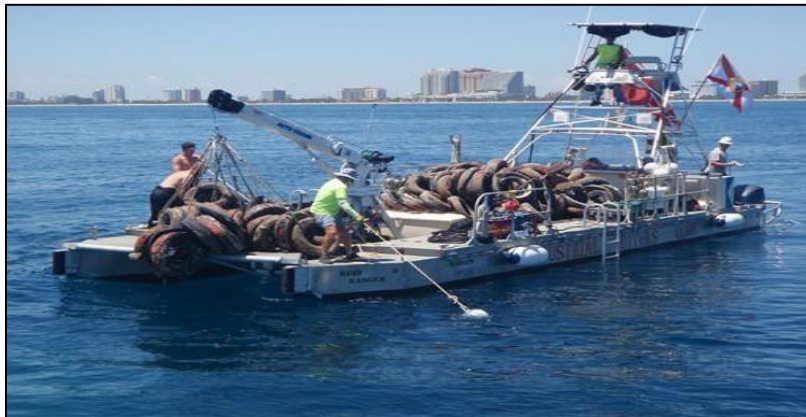
Image 10. Current commercial tire removal operation using a similar method to that used during the DoD Program. Once the support vessel is loaded with approximately 300 tires, the vessel will return to Port Everglades to offload the tires into an open-top container (Photo: IDC).

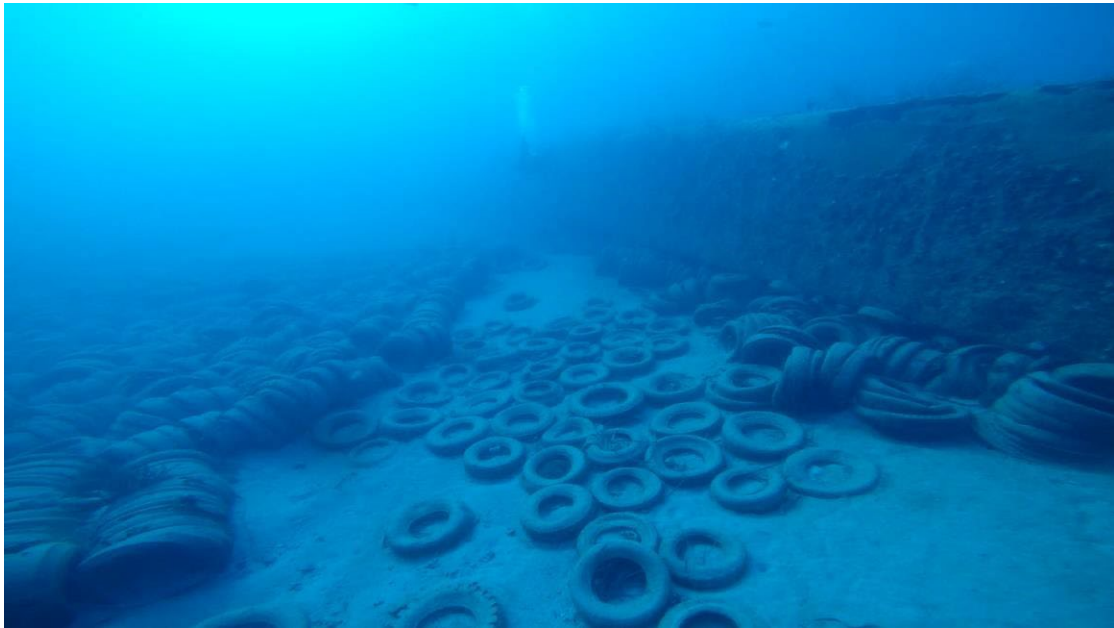
Image 11. View of individual tires and tire bundles in the sand next to “Matt’s Barge”, a previously placed artificial reef. This image was taken in 2017 prior to tire removal (Photo: IDC).

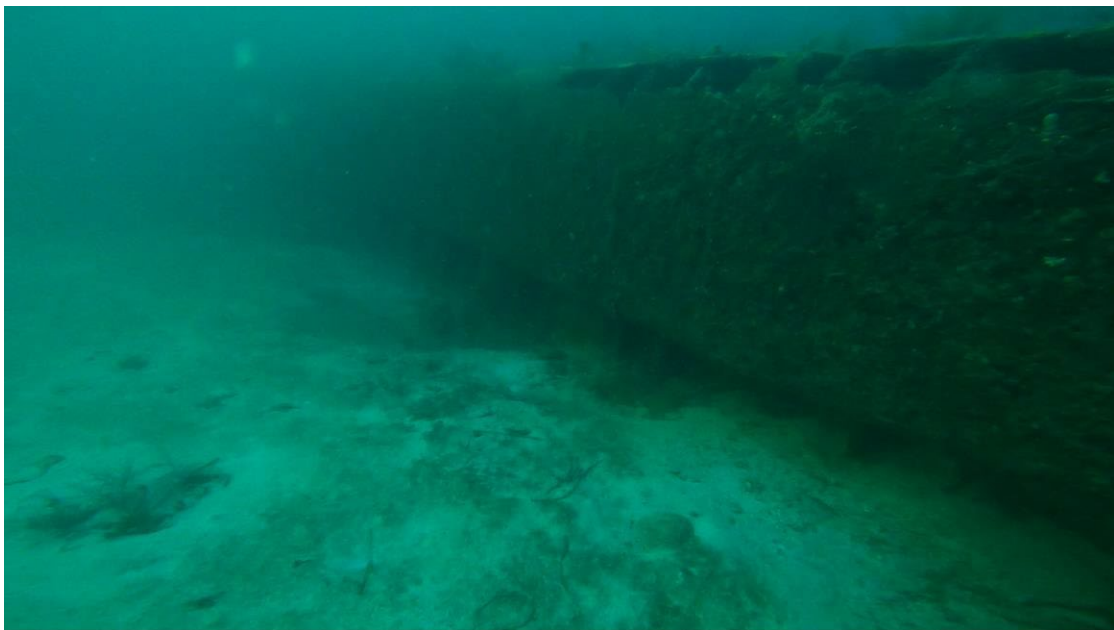
Image 12. A view of the sand next to the same barge in Image 10 following tire removal in 2023 (Photo: IDC).

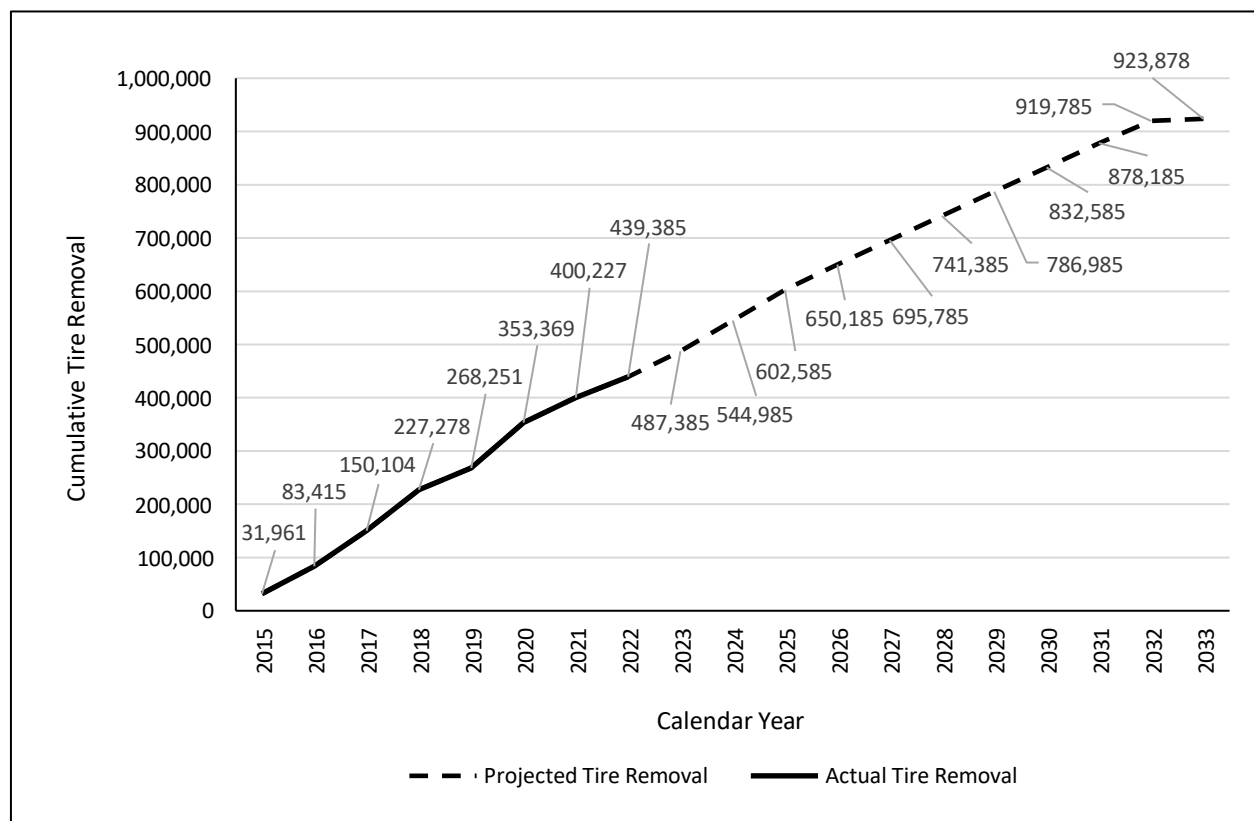
Figure 6. Actual and projected cumulative tire removal from the Tire Abatement Permit Area during each calendar year between 2015 and 2033. This graph does not include the 1,600 tires removed by NSU, the 72,000 tires removed by the DoD Program, nor the 414 tires removed by 4Ocean.

For future tire removal efforts, the projected number of tires to be removed each calendar year, using only the current methods from the Tire Abatement Project, ranges between 41,000 to 57,000, except in 2033 when the remaining several thousand tires will be removed (Table 1; Figure 6). Projections are based on currently permitted methods (which includes removing buried tires) within the Tire Abatement Permit Area and past performance by the commercial divers, but with fewer tires removed over time as less dense areas are targeted. As tires are removed and density decreases, the effort to locate, bundle, and send to the water surface the same number of tires for a full vessel load (approximately 300 tires) takes more effort and time, which can also result in increased costs per tire. DEP is exploring whether a contract amendment and permit modification may be needed to expand the Tire Abatement Permit Area to locations with higher tire densities.

It is important to note that the projections in Figure 6 will likely need to be adjusted for differences in methods and costs required to remove tires located on reef habitat and in deeper waters. Tire removal from the reef will require more restrictive methods to reduce impacts to reef organisms and habitat. Tires in deeper waters are likely to require increased restrictions in bottom time and different equipment. The accessibility of tires in contact with reef/hardbottom, their potential impacts, and necessary restoration techniques will be assessed in the Restoration Plan due July 1, 2024.
